Control of
Mine Tailing Discharges
- To Big River

a report prepared by

The Department of Natural Resources
January 1980

CONTROL OF MINE TAILING DISCHARGES INTO BIG RIVER

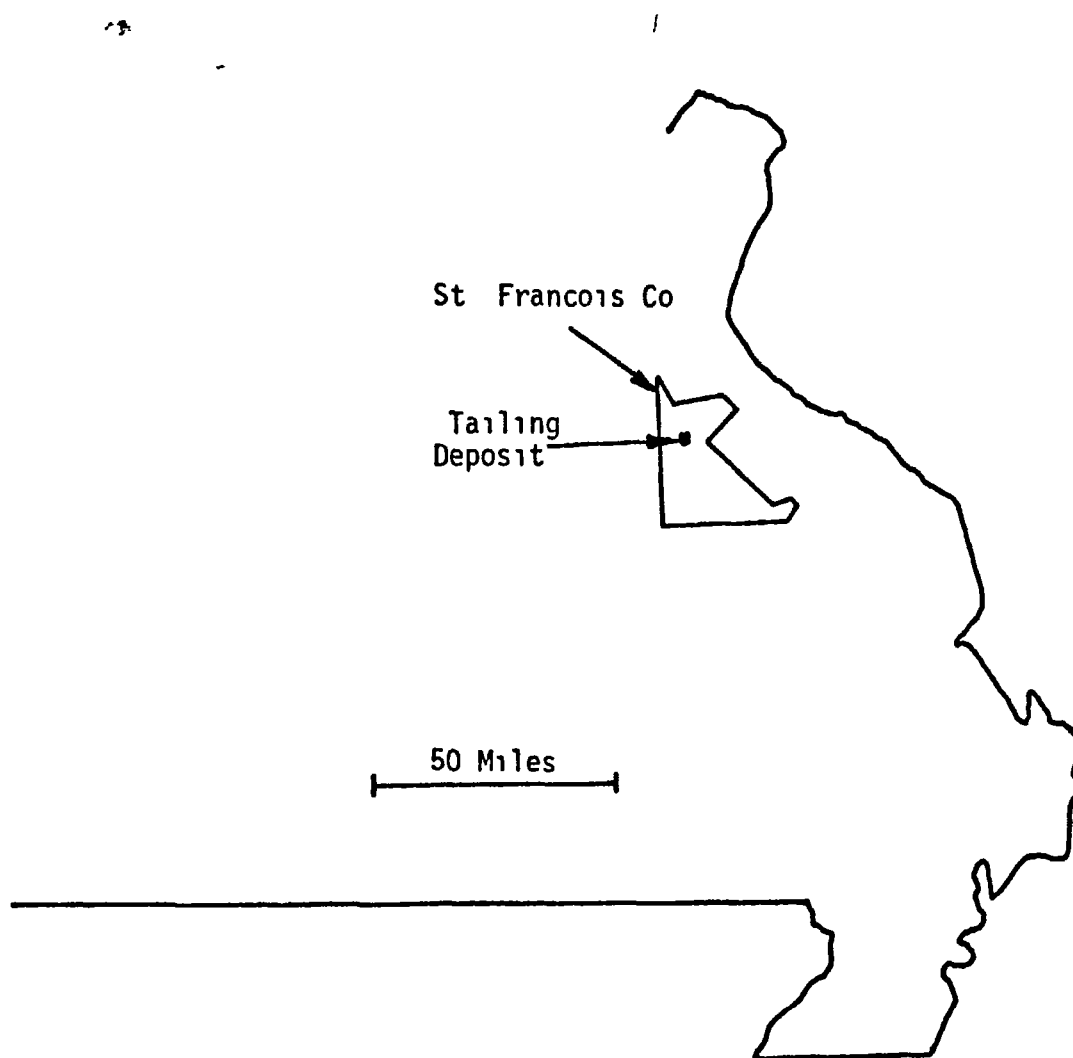
Approximately 2 years ago (1977) a section of the tailings pile washed into the Big River. Although the exact quantity of material which washed into the river is not known, estimates suggest this quantity could have been as large as 50,000 cubic yards. Physical evidence suggests that much of the erosion which has taken place at this location occurred in a single event.

Fig 1 Site of the 500 Acre Tailing Pile Which is Discharging Tailing Into Big River

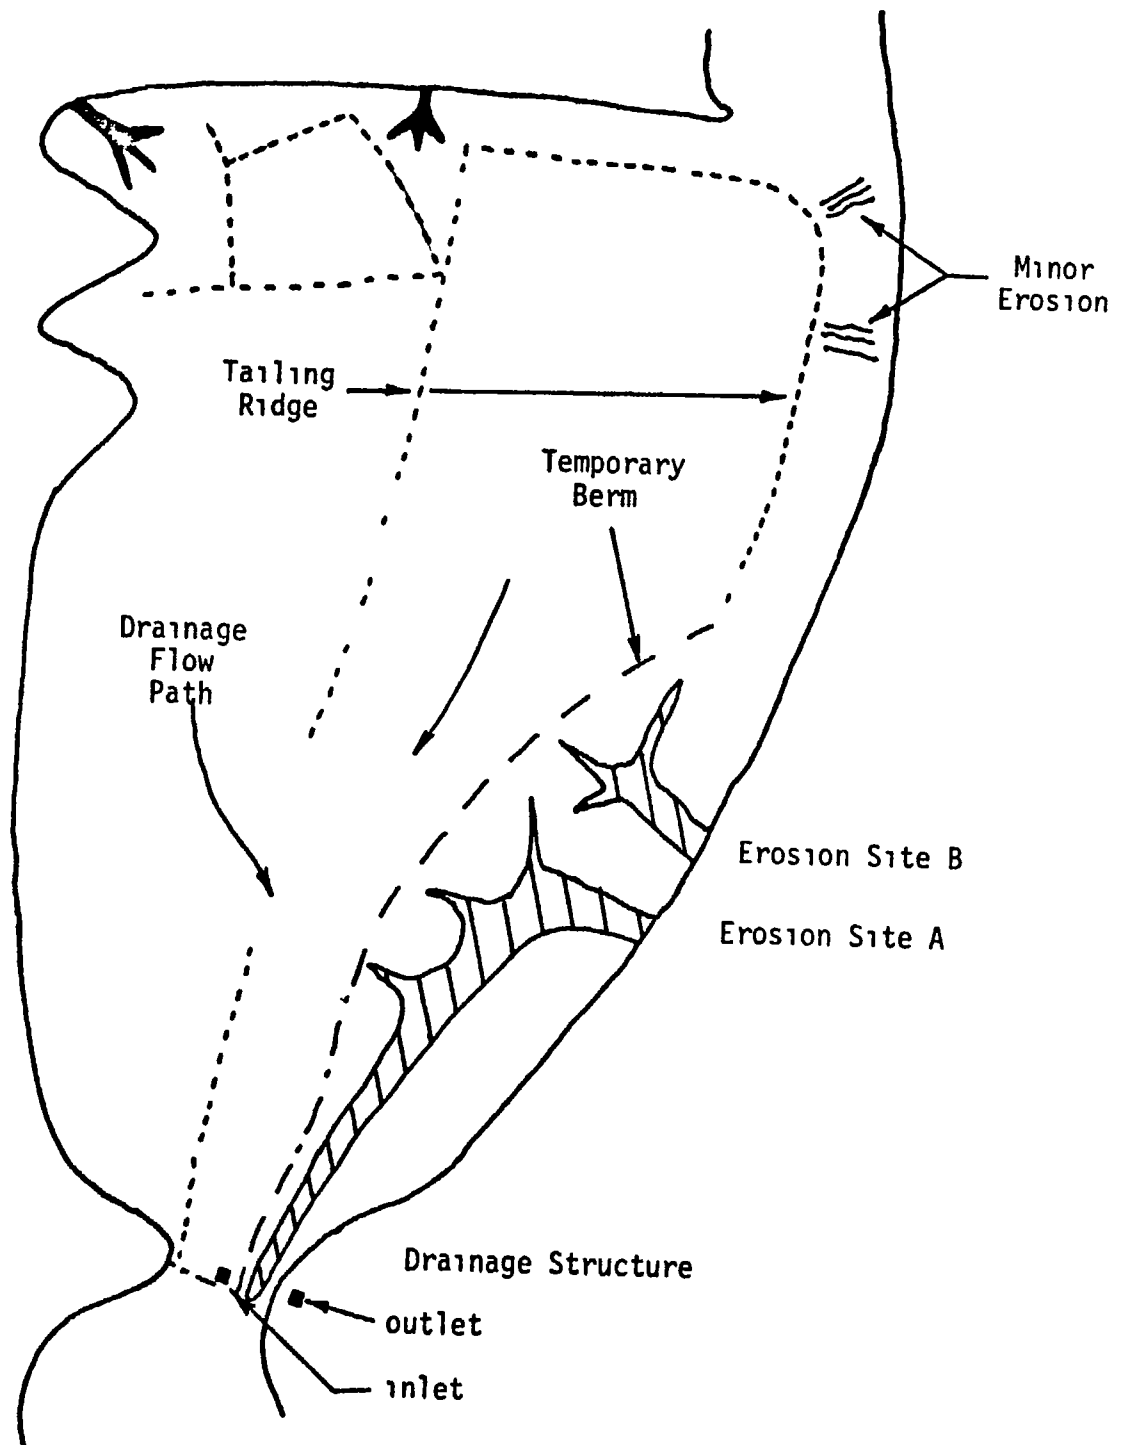
A sketch of the site is shown in Figures 4 and 5. The location of the major source of tailing discharges is shown on Figure 5. At this site, approximately 90,000 cubic yards of material has been displaced. Some of the displaced material has entered the stream and some remains adjacent to the pile in the woods between the pile and the river (see Figure 6).

Fig 5 Plan View of the Upper Portion of the Tailing Pile

A sketch of the site is provided in Figure 4. At present there are about 8 sources of tailing discharges. Each of these is indicated on the series of sketches in Figures 5, 16, 17, and 18. The most serious is the site shown in Figure 5 where two separate erosion sites exist. In Figure 19, a series of profiles are shown for site A. Although there are some discontinuities and side ditches in this gulley, it can easily be represented as a triangular section. The volume of material which has been displaced is estimated at 90,000 cubic yards. Some of this material is located at the foot of the pile in the woods and a larger fraction has been washed downstream. Minor erosion continues at this site.

It is recommended that the 90,000 cubic yards from site A be entirely replaced. It is recommended that the ditches at site B be filled and that a surcharge of material of ten feet in depth be added to this area so that this location is raised to an elevation above that of the main portion of the pile. The corrections at site B will require approximately 40,000 cubic yards of material.

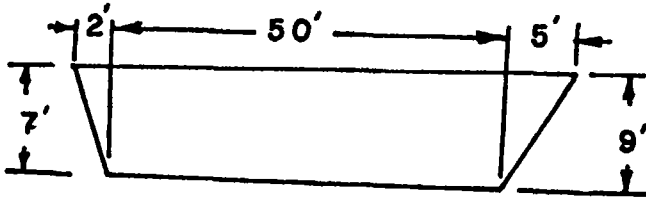
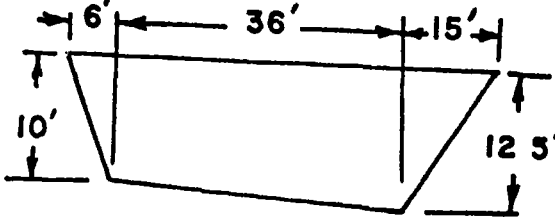
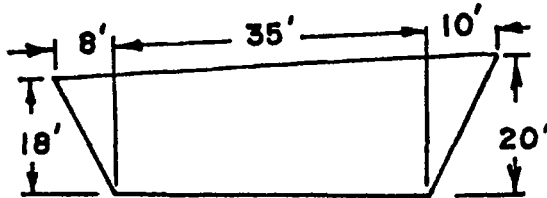
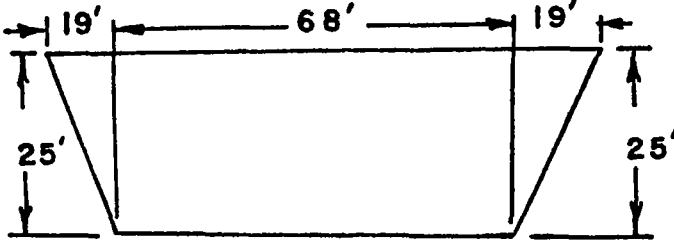
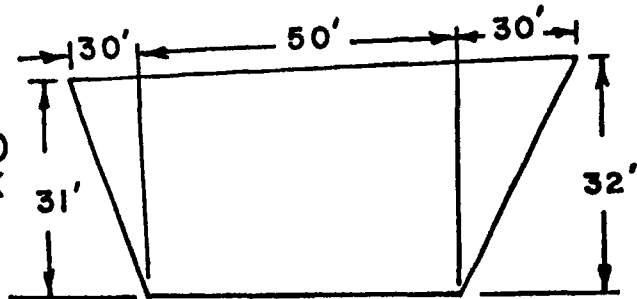
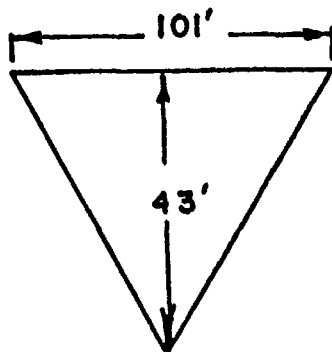
Fig 19 Plan and Cross-Sections of the Major Gully

Deposition of approximately 40,000 cubic yards of tailings into the large gully and mechanically reducing the steep slopes should eliminate most of the erosion problem although the large ditch will remain and will be a potential source of problems if the drainage structure fails to perform

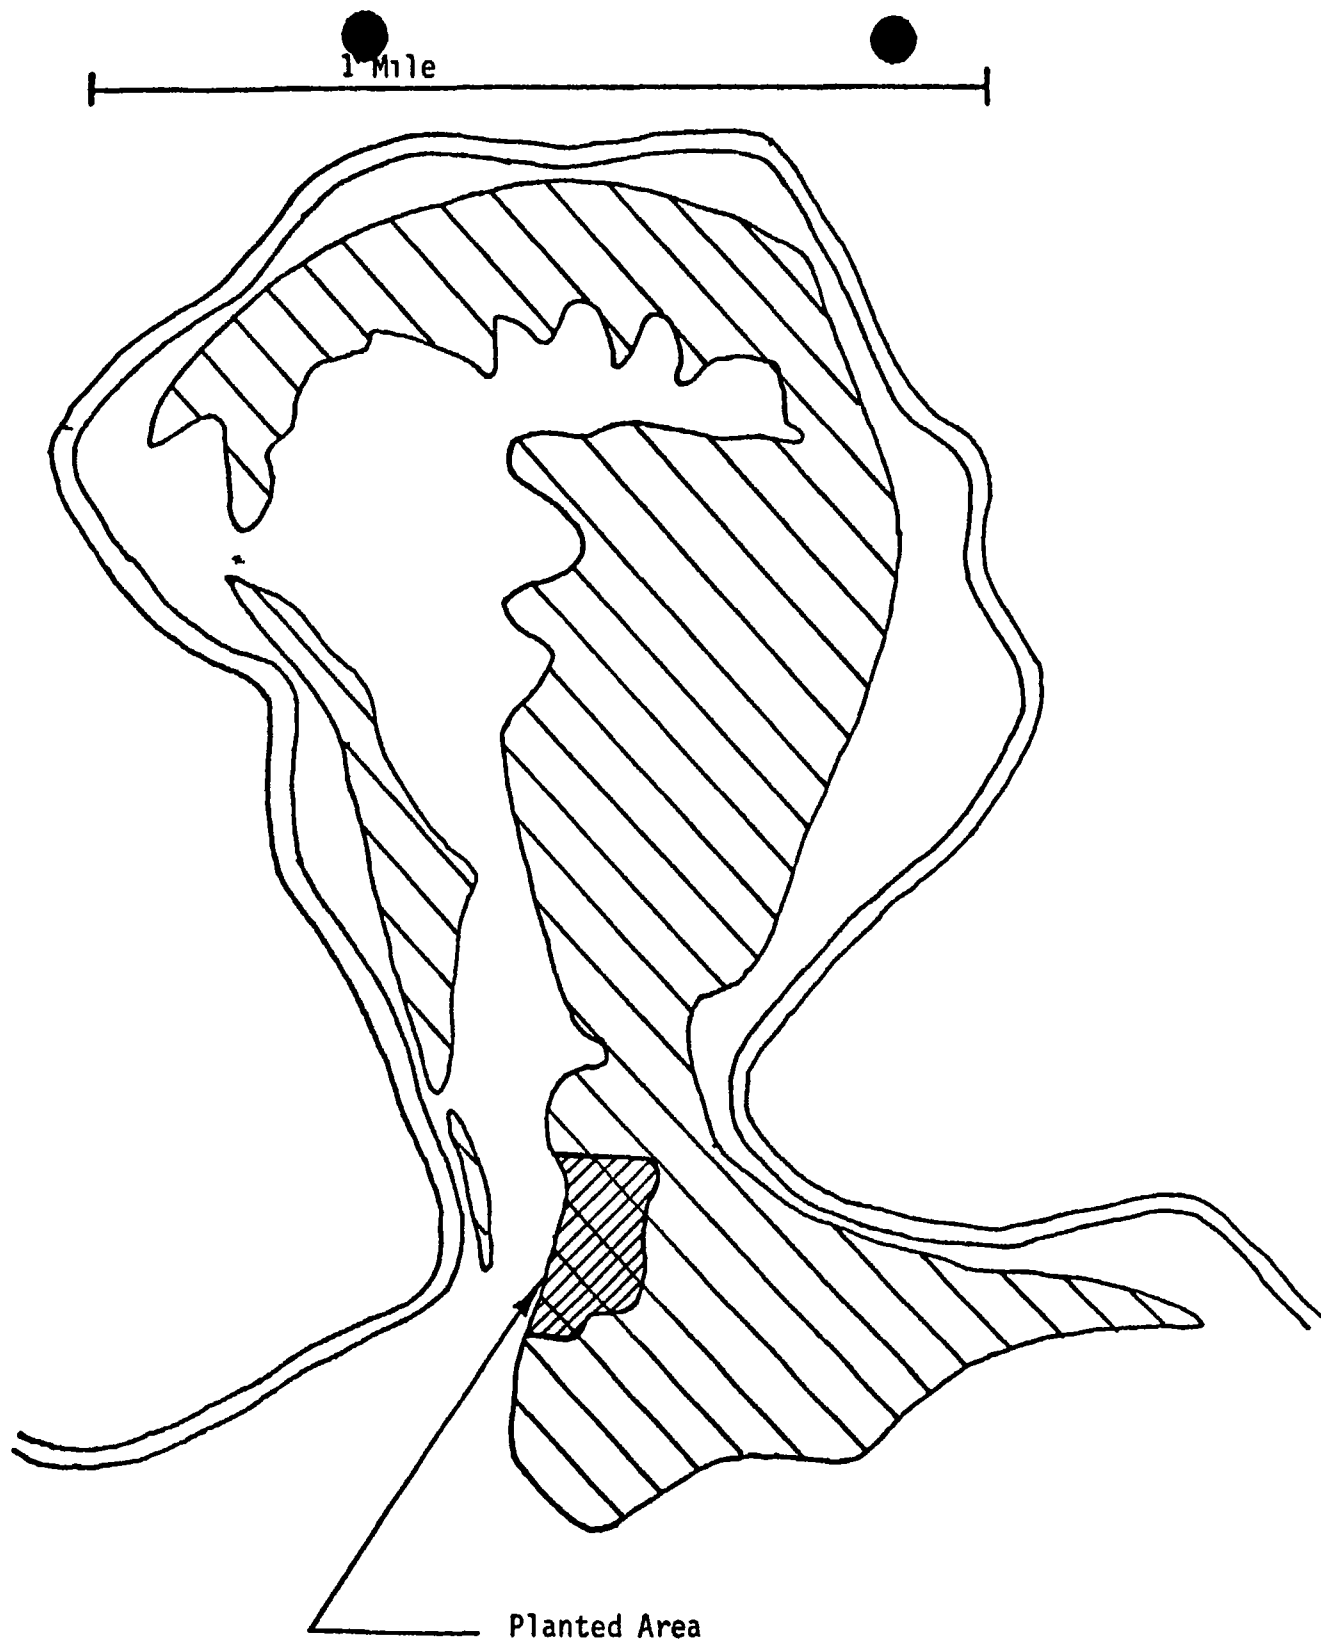
A stand of fescue has been established at one location (Figures 27 and 28). Considerable erosion has occurred around the root structure of these plants. The fescue plot is located in a flat area behind a small ridge where water often pools. This fescue plot provides ample evidence that grasses can be established where wind erosion is not severe and where slopes are not steep.

Fig 28 Location of Fescue Stand

Distinct lines of demarcation occur between grasses. The succession could be due to moisture availability or mineral content of the soil material.

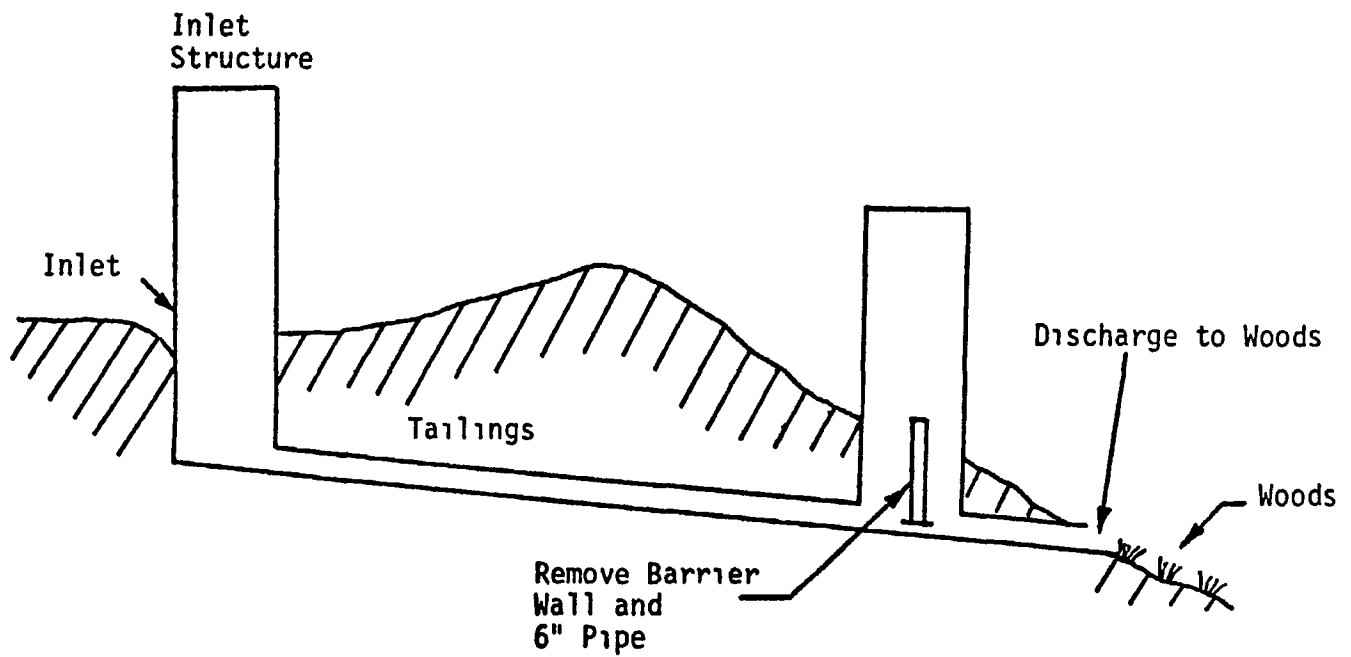
The outlet structure of most interest is that shown in Figures 4, 10, and 11. This structure is connected to another drain tower as shown in Figures 11 and 12. Apparently, this structure became blocked during a period of heavy rainfall and led to the massive erosion which occurred at Sites A and B. This structure is now functioning properly but is subject to plugging. Plugging may occur at the entrance to the structure but probably occurs in the secondary structure where the small pipe connects the two cells. During field investigations over the summer of 1979, the connecting pipe, shown in Figure 13, was found to be partially blocked with debris.

The purpose of the wall and connecting pipe was probably to reduce the discharge velocity so that erosion on the outer slope would not occur. It is probable that the structure worked as intended for some time but in recent years, pieces of wood resulting from deterioration of the hydraulic fill structures (Figure 14) have been washed into the structure causing plugging.

Fig. 32, Profile of Drainage Structure No 1

The installation of additional drainage structures is not proposed. Of the three existing drainage structures, only structure No. 1 (Figure 10) requires modification. Drainage structure No. 1 is a double tower arrangement. Blockage appears to occur at the second tower at the center wall and small pipe. These should be removed as shown in Figure 32. In addition, some of the silt which has been deposited at the water inlet should be removed and the area altered to permit easier water access to the structure. It appears that when the 6 inch pipe becomes blocked in the second tower, silt deposits in the bottom of the water inlet structure and connecting pipe (Figure 32). Silt deposition in the connecting pipe can be reduced by removing the barrier wall and pipe and reducing the amount of debris that enters the structure.
